Reduction and Control of Sediment-Laden Runoff to Coastal Waters through the Implementation of Best Management Practices (BMP's), Coastal Habitat Rehabilitation and Delimitation of Public Access at Culebra, Puerto Rico

FINAL REPORT

August, 2015

*Projects toward the implementation of the Culebra
Community Watershed Action Plan for Coral Reefs and Water Quality*

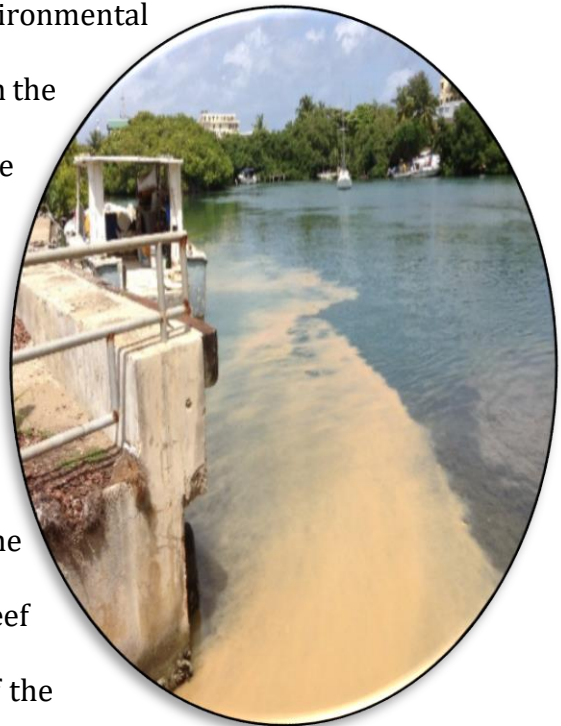
Figure 3 (Top). Runoff with fine sediments and beach erosion problems at Zoní Beach prior stabilization. Picture from the UPRM Sea Grant Program Marejada Magazine. **Figure 4** (Bottom). Sediment plume out to the Lobina Channel from the town site prior stabilization.

Zoní was selected as a high priority location due to the erosion occurring on the road network driving down to the beach and of the parking lot which allowed conveyance of untreated stormwater into the nearshore marine environment and coral reefs (Figure 3). The Townsite was identified as a priority due to extensive sediment transport from a dirt road and conveyance of stormwater runoff in a small eroding channel out to the Lobina Channel (Figure 4).

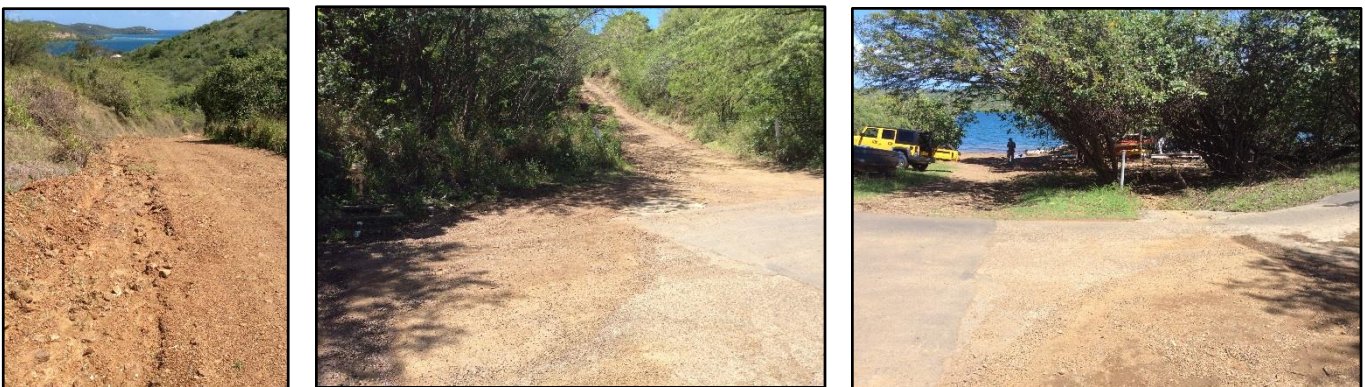
Figure 5. Example actual unstable dirt roads in Culebra.

Increased levels of land-based sediment loads associated with coastal development is one of the most important factors affecting coastal marine ecosystems in Puerto Rico. Puerto Rico coral reefs are among the most threatened marine ecosystems in the Caribbean. High sediment loads to marine environments resulting from poorly maintained dirt roads without the installation of proper management practices is a very common problem in Culebra (Figure 5).

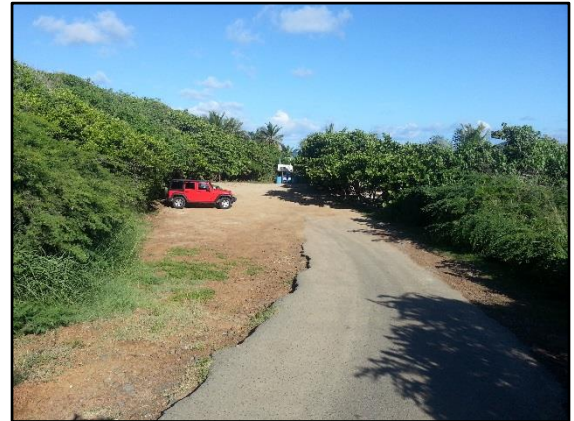
Figure 8. Parking lot prior stabilization.

The problems identified in Zoní beach were mainly associated with runoff generated from the dirt parking lot (Figure 8) and the unpaved road network that provides vehicular access to areas adjacent to the beach (Figure 9). Existing infrastructure was in a critical state of disrepair with rutting and small undesirable watercourses conveying runoff and sediment down to Zoní Beach (Figure 10). The dirt parking lot covers approximately 500 m² and vehicles had direct access to the permanent vegetation areas of the beach. The lack of proper planning and management of erosion and sediment led to an increase in contamination of the beach with sediment and pollutants associated with motor vehicles. After several field evaluations, input from the local community, DNER, FWS and NOAA the following restoration components were established (Figure 11):

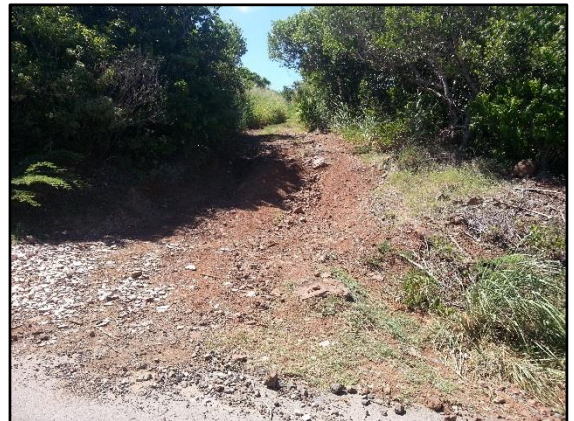
Figure 9. Dirt road prior stabilization.

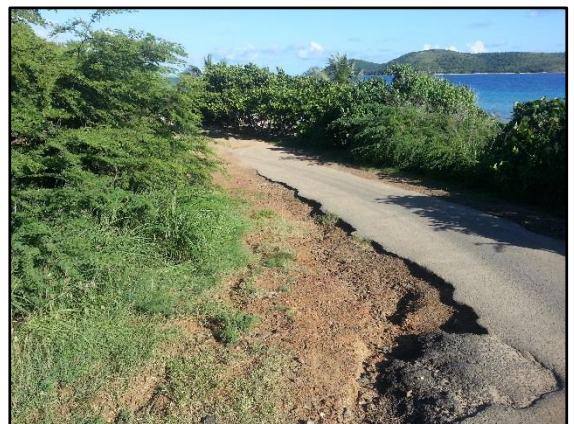
Figure 10. Undesirable watercourses prior stabilization.

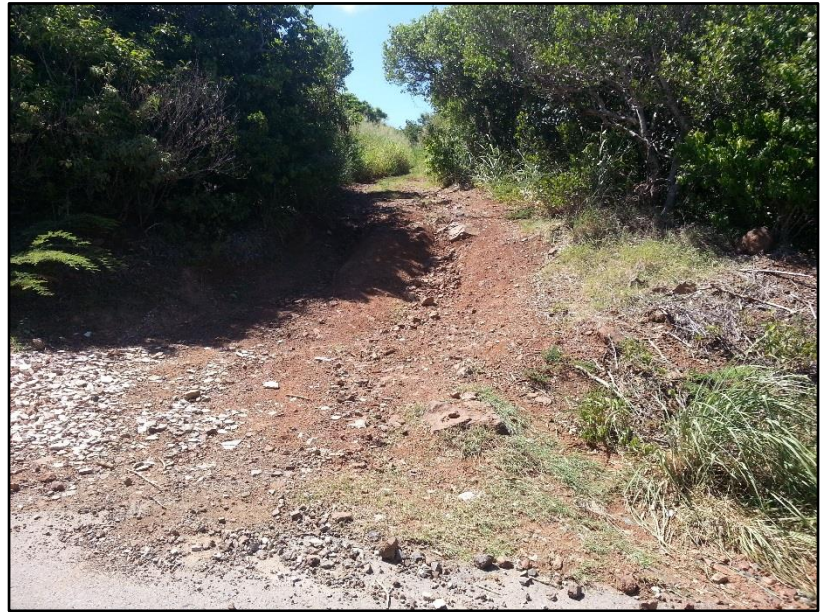
Figure 12. Dirt road prior stabilization.

to Zoni Beach. The stabilization of this dirt road has significantly reduced the amount of flow and the velocity of water and sediment sent downhill. Water had converted this road into a drainage channel increasing the velocity of the water running towards the road to Zoní Beach (Figure 12). Restoration work at this site consisted of diverting runoff water to forested areas in 4 to 6 segmented locations. To stabilize this section of road, we installed dirt swales, thus reducing flow and diverting water to adjoining forested areas.

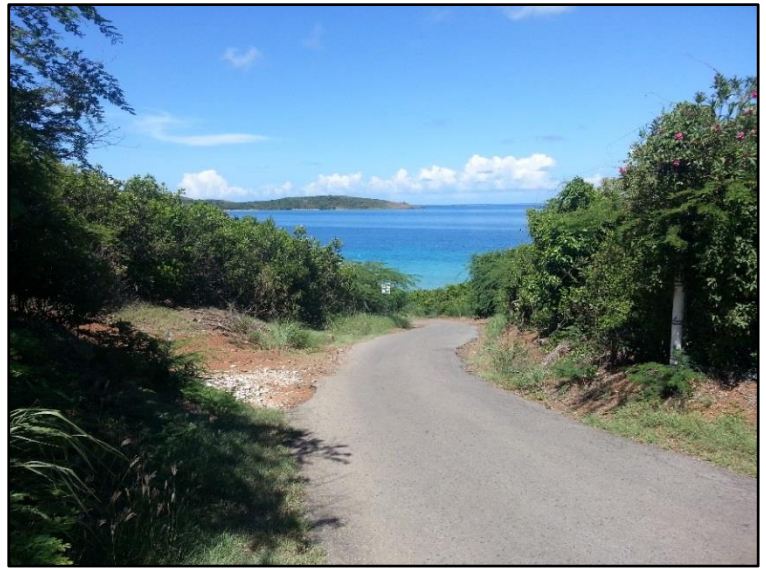
Figure 13. Paved road prior stabilization.

Previous to our intervention the paved access road served as the flow pattern of runoff to the parking lot area (Figure 13). In order to reduce runoff and dissipate its energy, water was conveyed to intercepts at 3 locations on both sides of the road that will

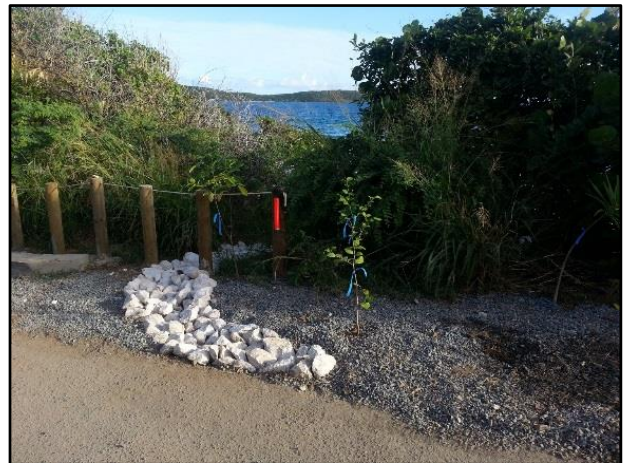
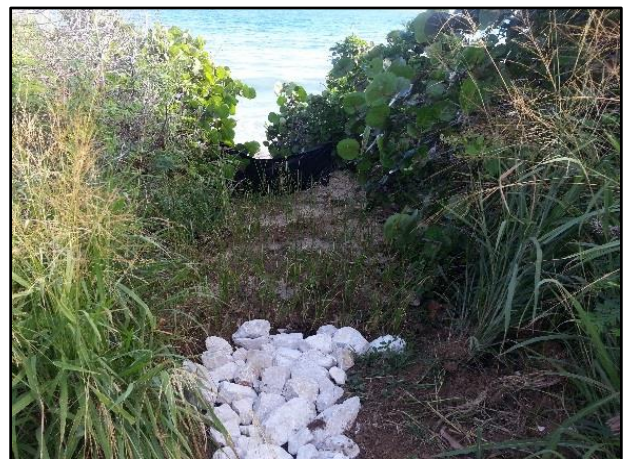
Figure 14. Flow intercepts.

break up flow paths and reduce concentrated flow of runoff over the parking lot (Figure 14). The excess runoff will be forced to a riprap and Vetiver swale built parallel to the south side of the road to take water off the road and it will end in a wider concrete bio-filter system with built-in large

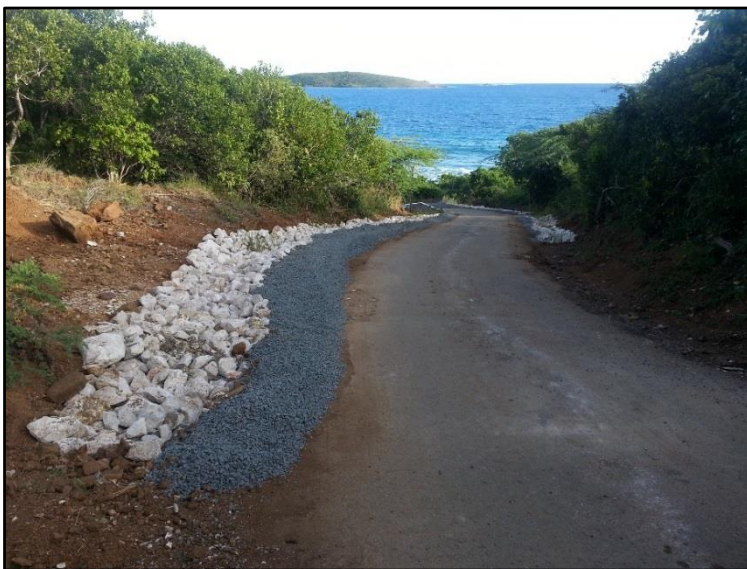
Figure 15. Riprap and Vetiver Swale.

stones that promote sheet flow towards the sediment trap after passing through several lines of Vetiver grass (Figure15). Damaged section of this road were repaired to prevent soils to be carried to the stabilized parking lot (Figure 16).

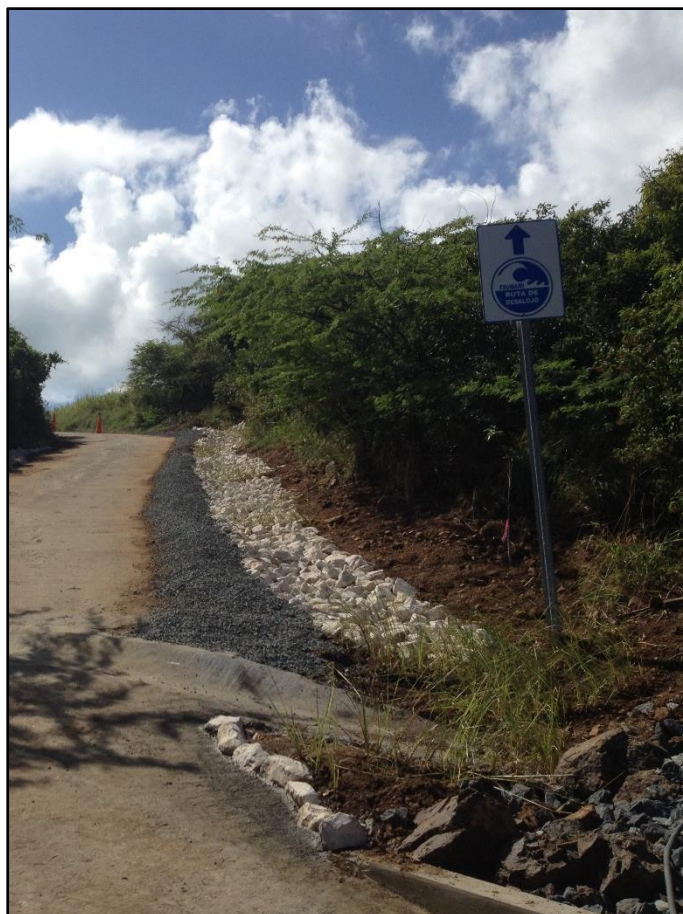
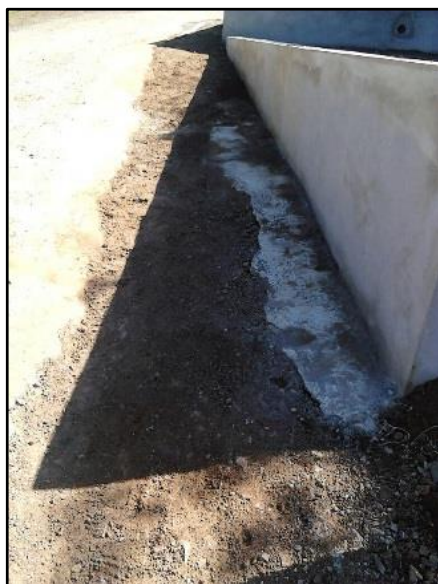
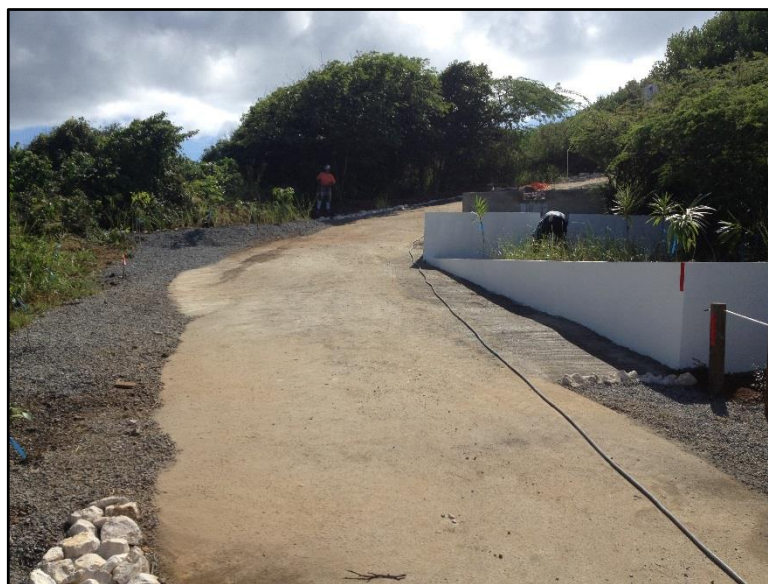
Figure 16. Pre and Post stabilization of paved road (Top) and repaired segment of the road (Bottom).

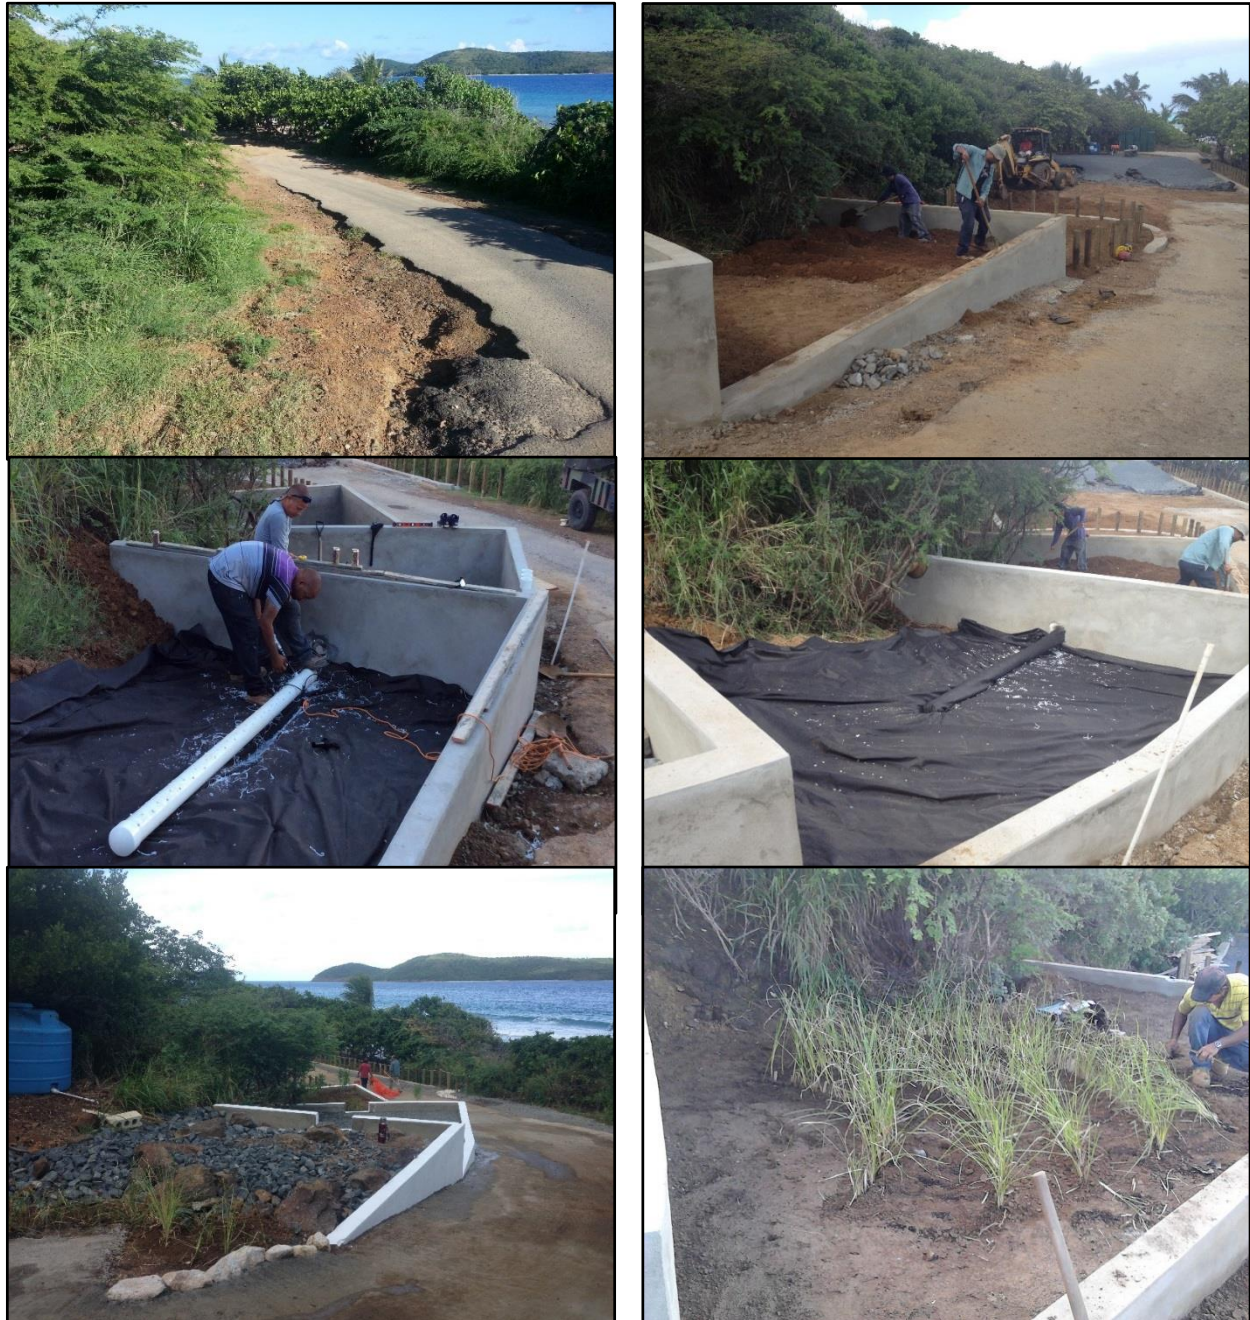
Figure 18. Construction of Filtration System.

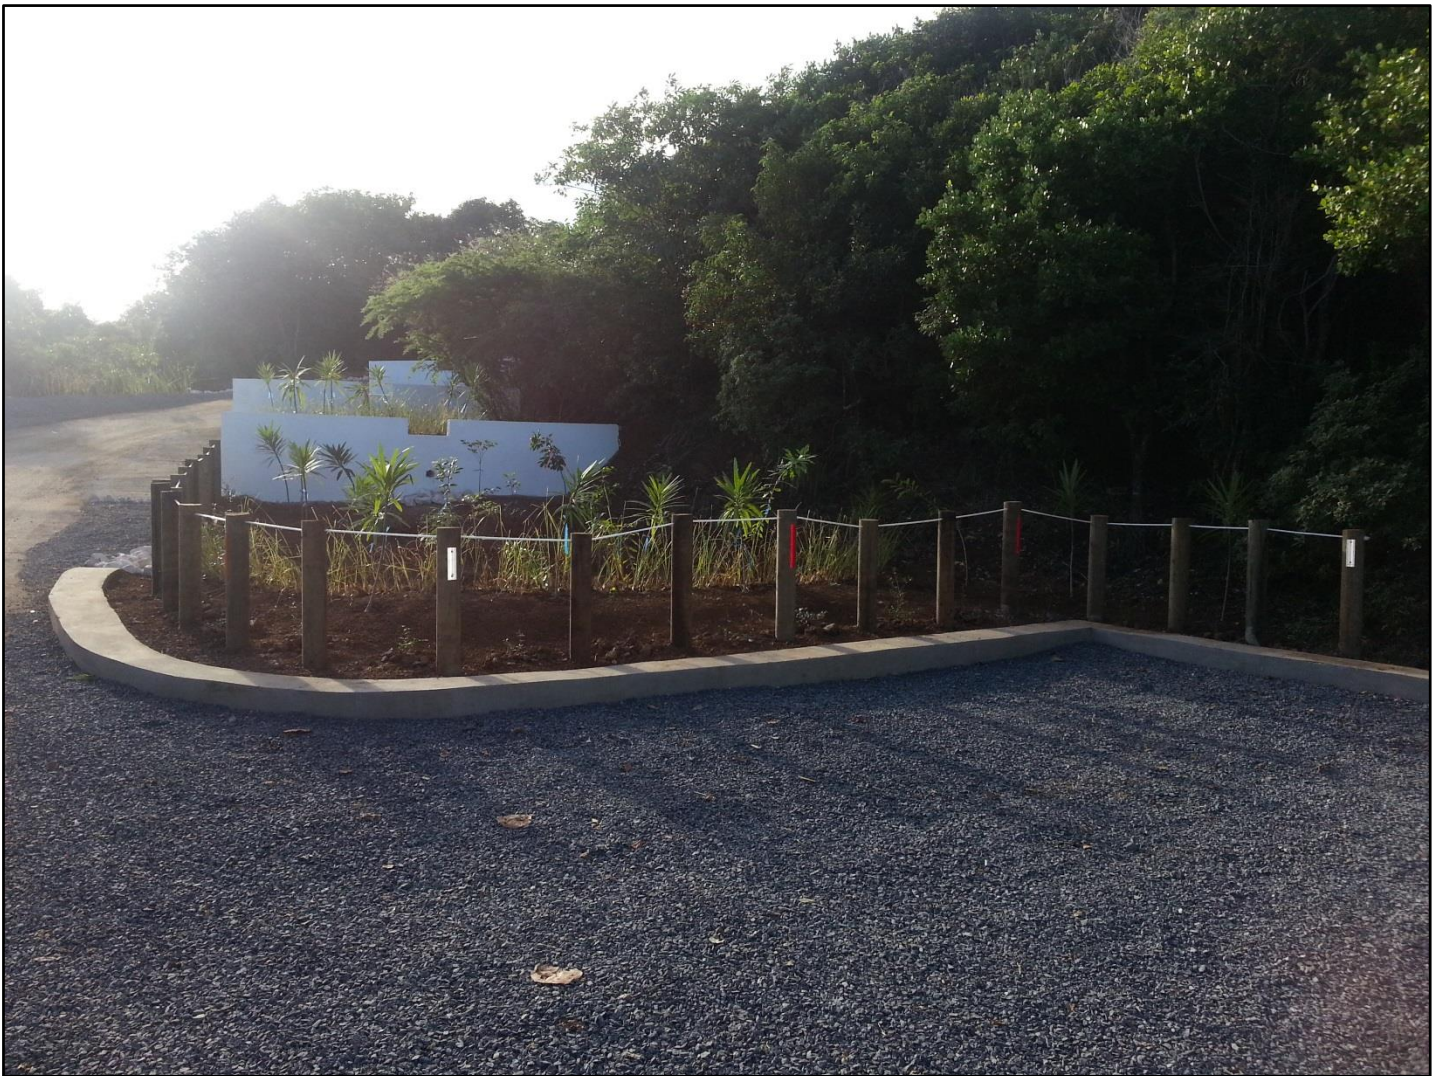
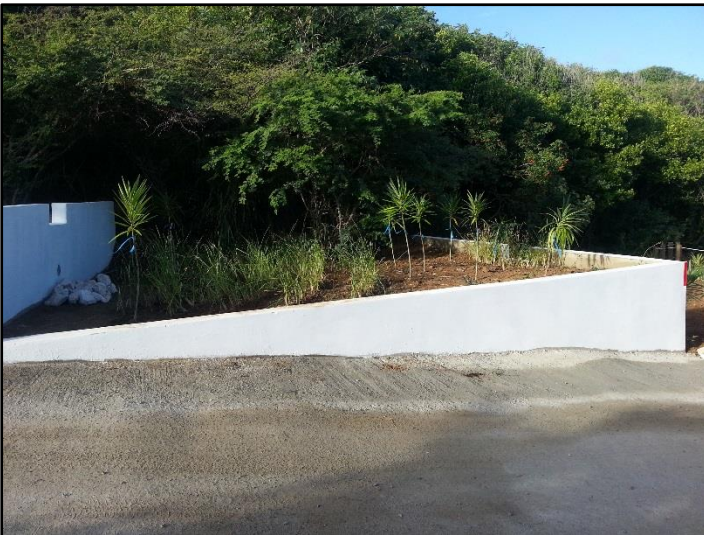
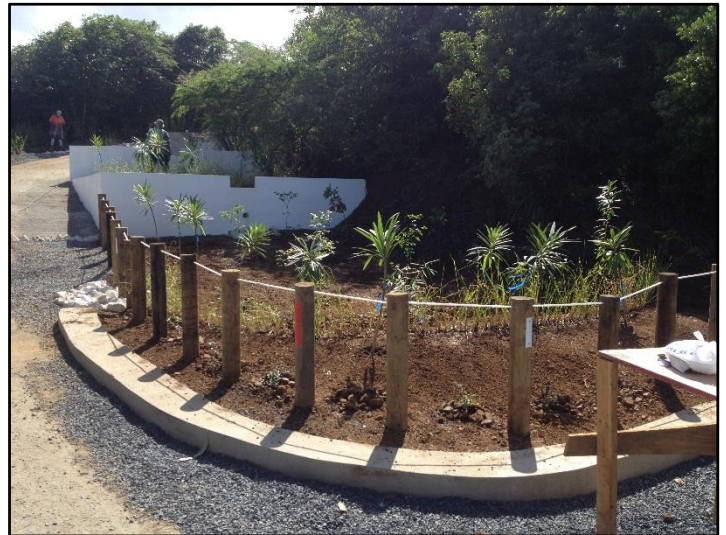
Figure 19. Rain Garden Component of the Filtration System.

At this point, sediment should be reduced significantly. A rain garden was placed at the end of the filtering process, this final step was designed to infiltrate small rainfall events and to discharge water slowly to the permeable parking area (Figure 19).

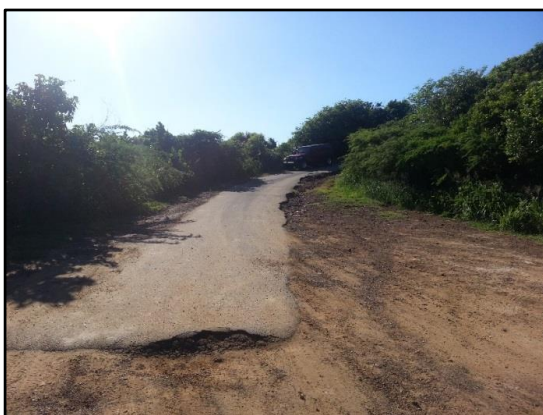
Figure 20. Parking area before stabilization.

The stabilized parking area consisted of approximately 500 m² (Figure 20). In this process, first, we delineated the parking area above the permanent vegetation zone of the beach. For this, treated wooden posts were buried about 18 inches deep and fixed with concrete at base leaving about 30 inches of pole to demarcate the area. Wooden posts were placed at a distance of three feet from each other and crossed with rope to prevent the passage of people and small vehicles such as golf carts that have become a major means of transportation in Culebra. Further, the parking area was developed using the best available technology to help in the sediment load reduction process (Figure 21). Parking was constructed with multiple layer base confined with a 1' concrete curb composed of; (1) geomembrane support (2) gabion with pebble stones as base, this allows support and drainage, (3) filter fabric, this eliminate the possibility of contamination of the base with sediment, and (4) a Geo-Cell with ¼" gravel infill, this will allow vehicle support and drainage of all stormwater (Figures 22, 23 and 24). Another important factor behind the parking design was the negative slope used to pond water at the center of the parking prior to its discharge

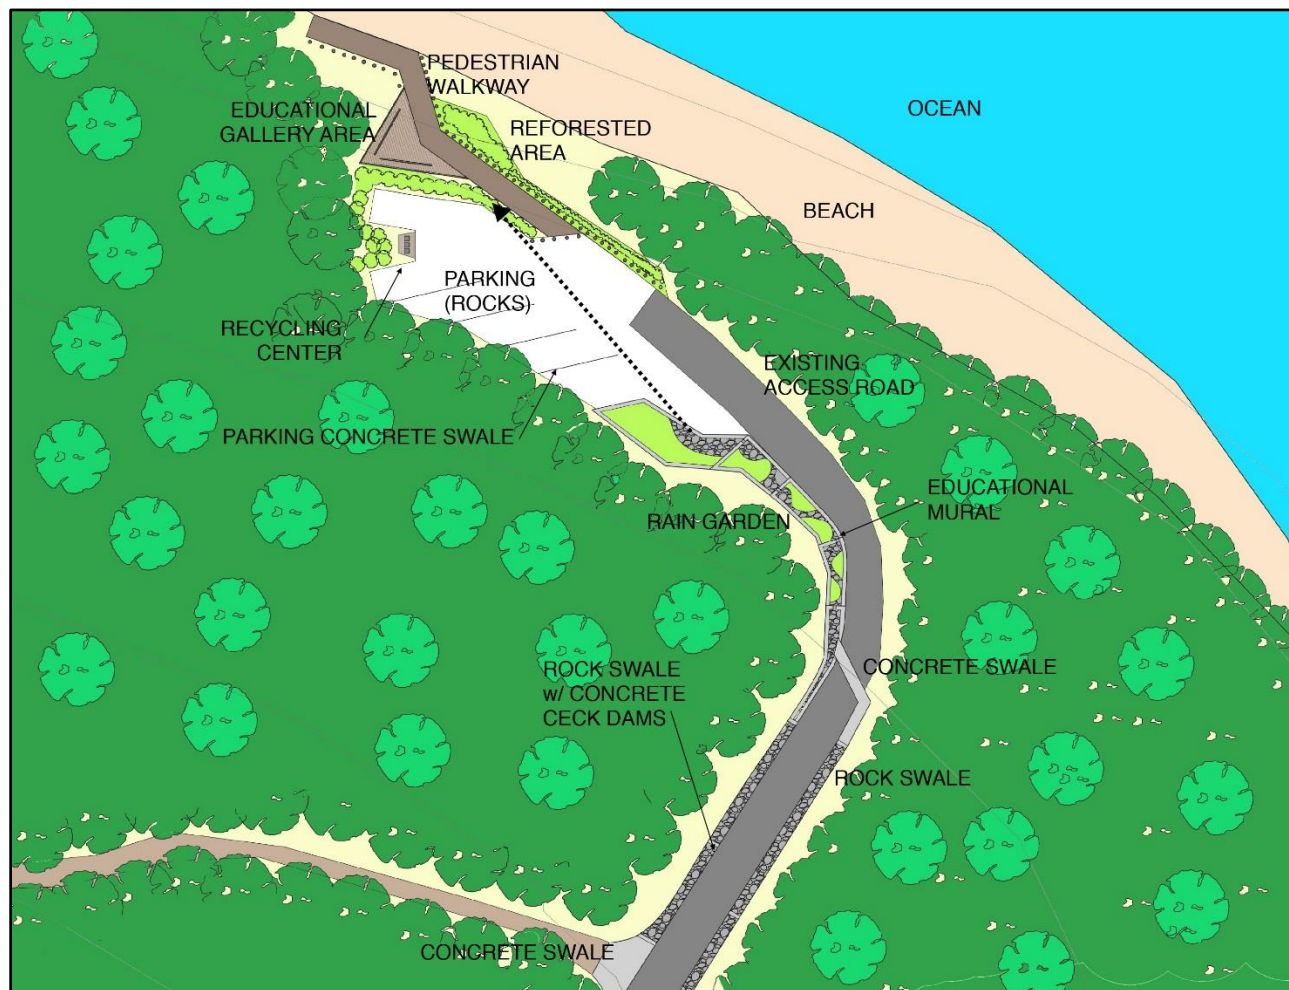
PERMEABLE PARKING

Figure 21. Schematic diagrams of practices Implemented (Top) and cross section diagram of parking filtration components.

throughout the beach channel. This will reduce significantly the discharge rate of storm water through the drainage channel which was re-planted with native vegetation to stabilize the erosion process affecting the beach.

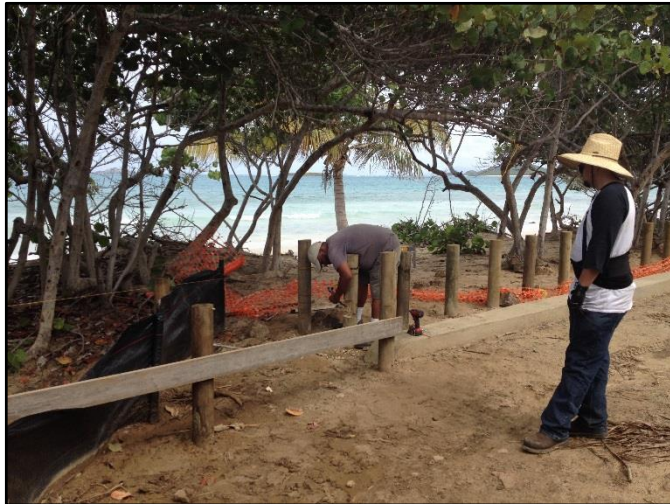
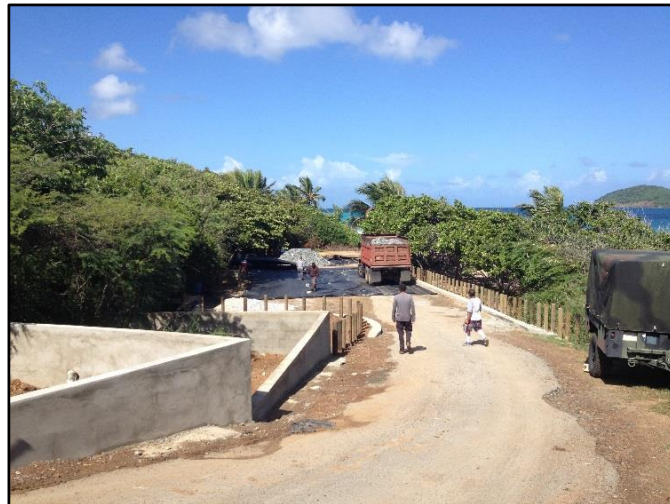
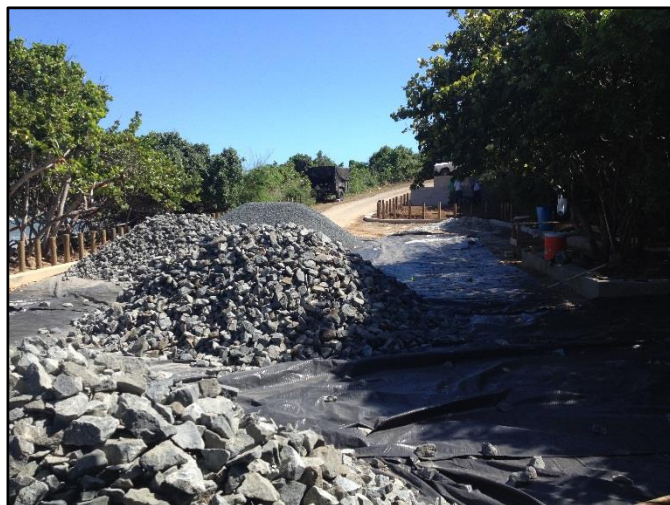
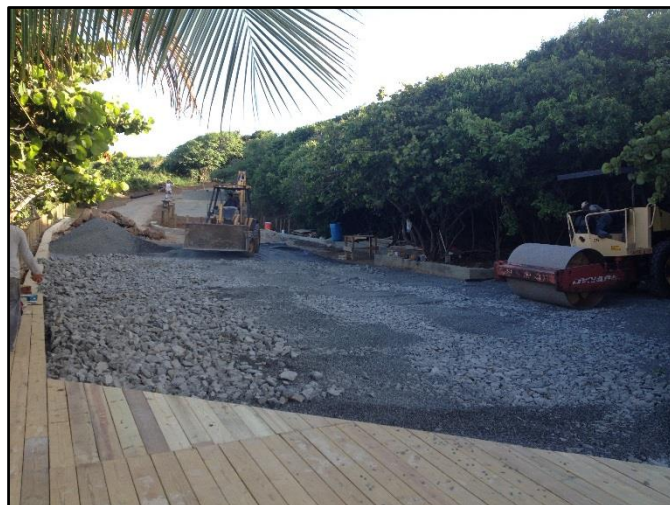
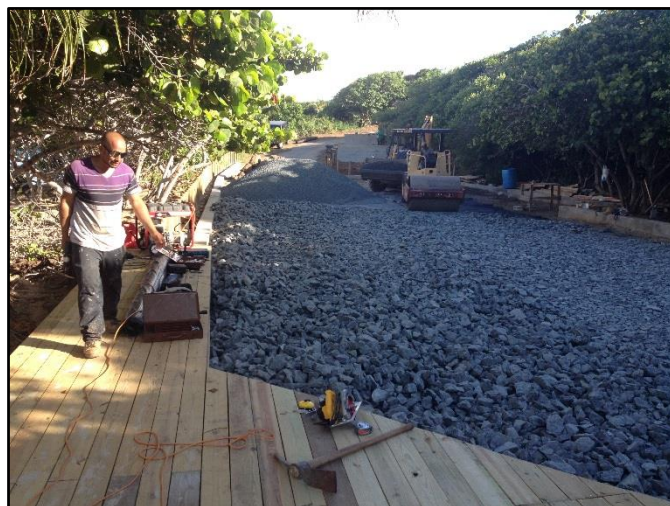
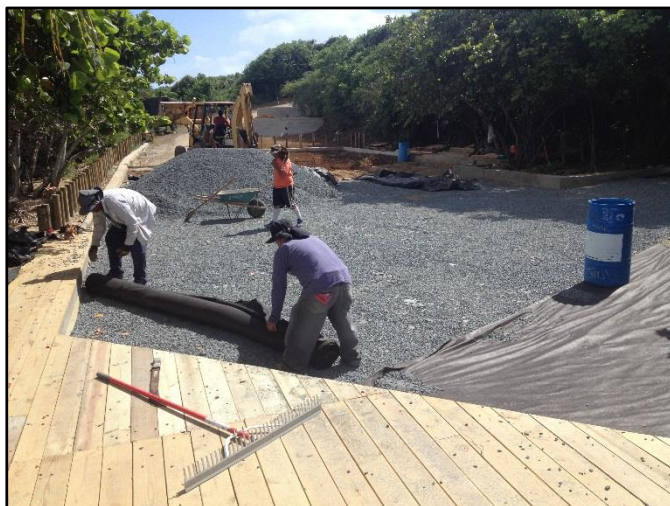
Figure 22. Parking filtration system construction.

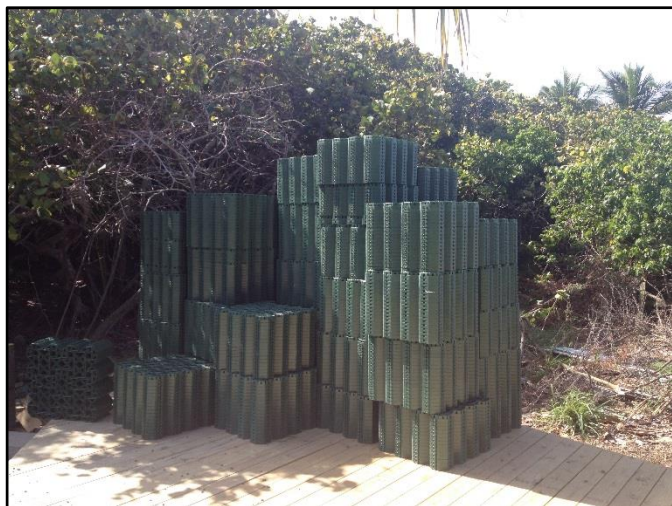
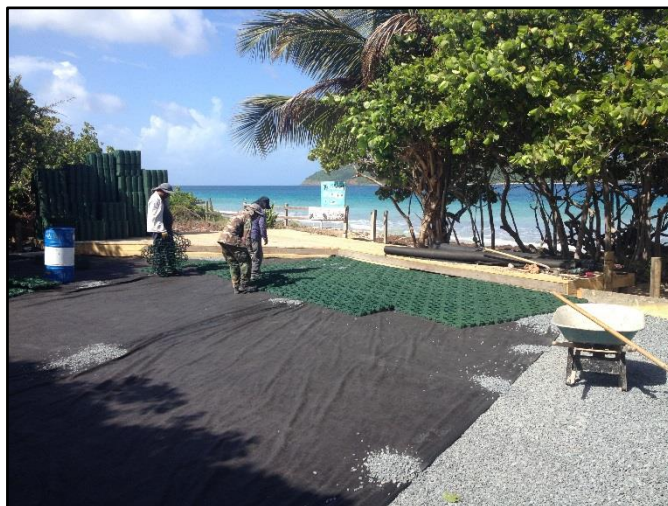
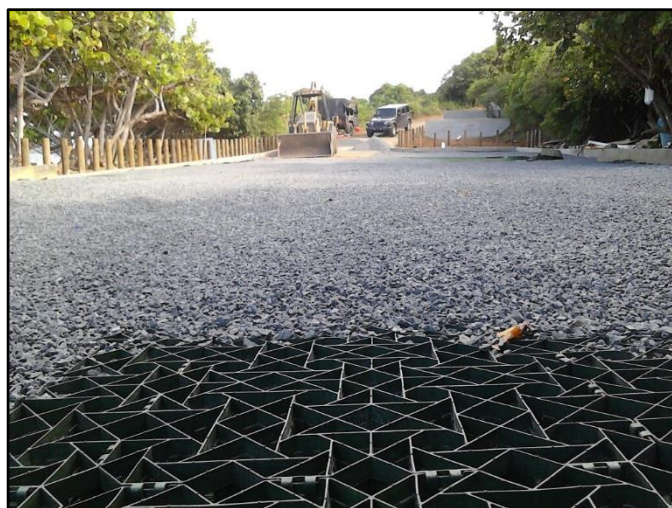
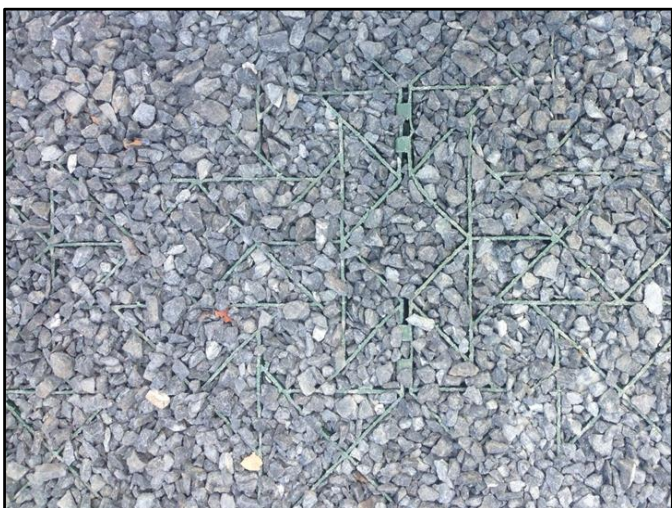
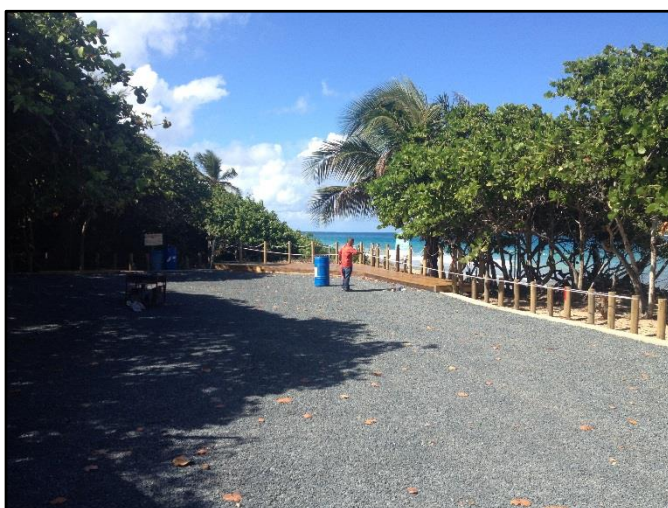
Figure 23. Parking filtration system construction.

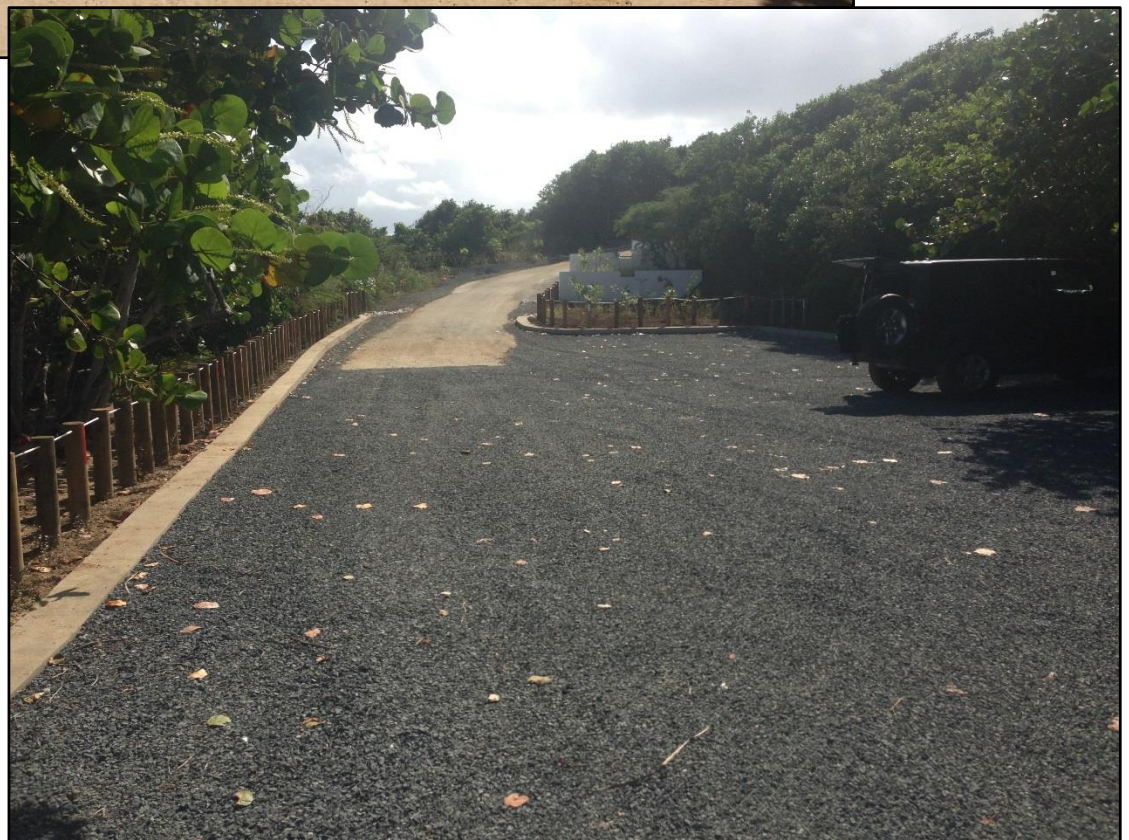
Figure 24. Parking area pre (top) and post (bottom) system construction.

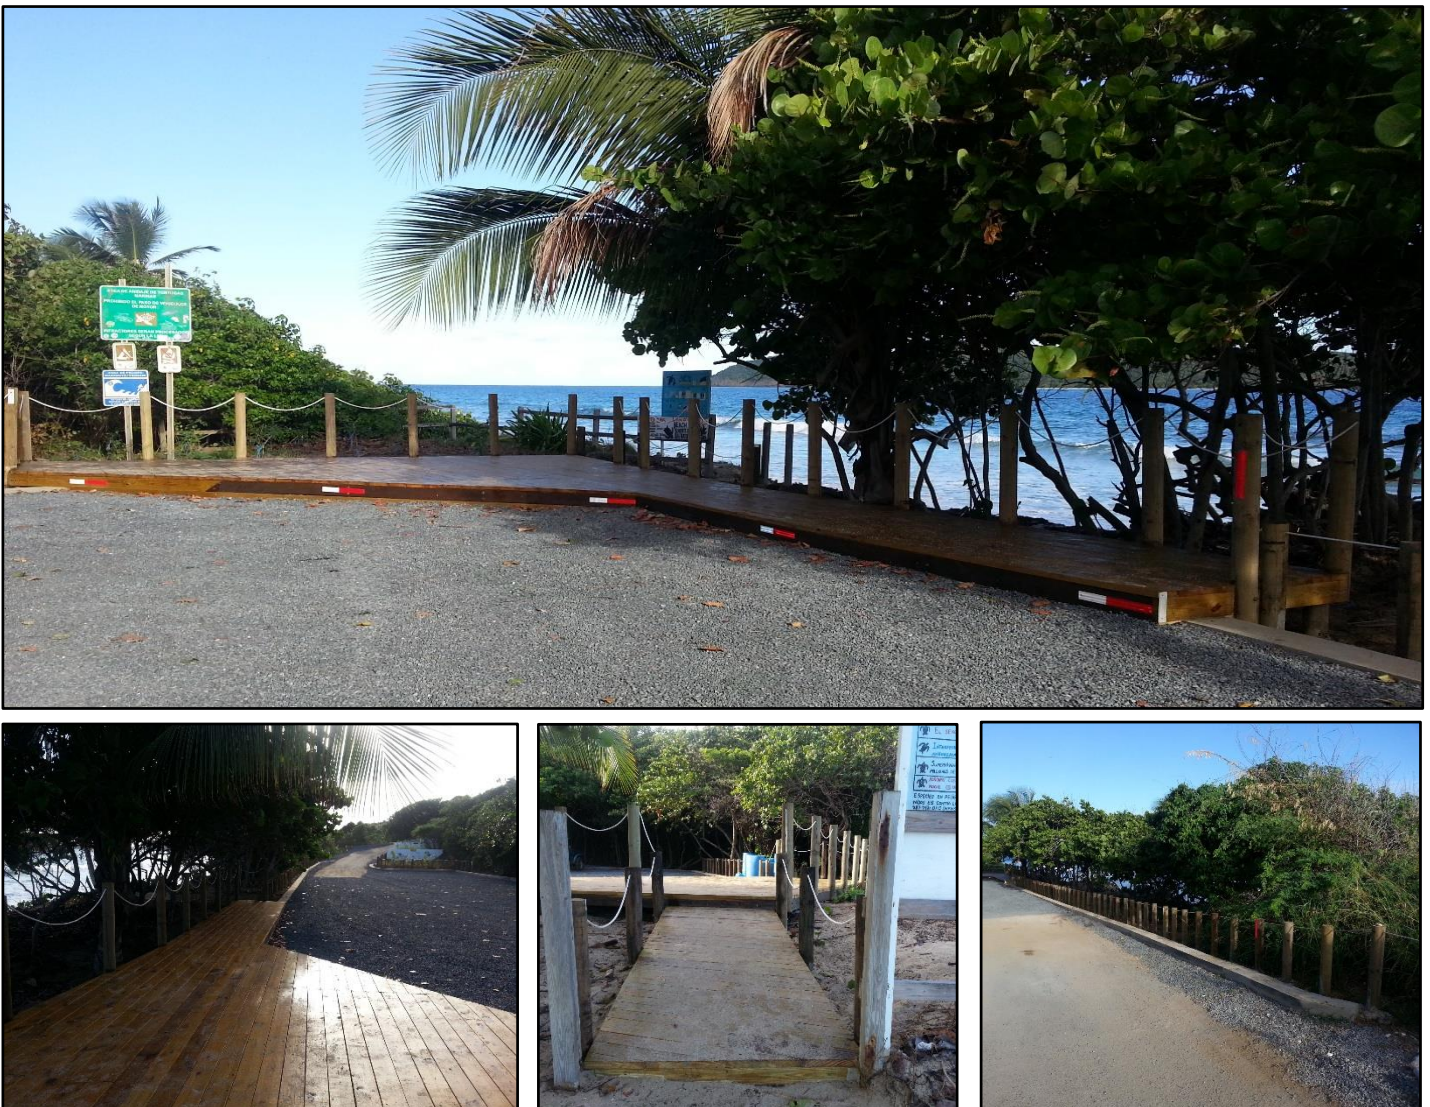
Figure 25. Elevated boardwalk and access delimitation.

A small elevated boardwalk was constructed for the public to access the beach without impacting vegetation and sand dunes (Figure 25). This area was closed to vehicular access by the installing wood poles and it has a defined pedestrian access area to the beach. This is accompanied by signage with educational information and rules to be followed by users.

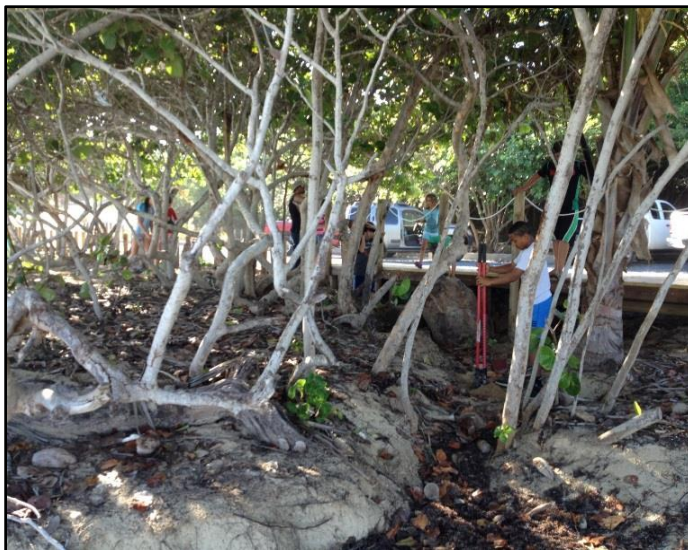
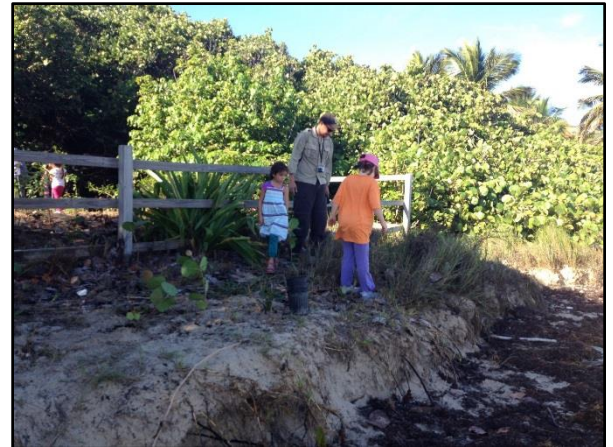
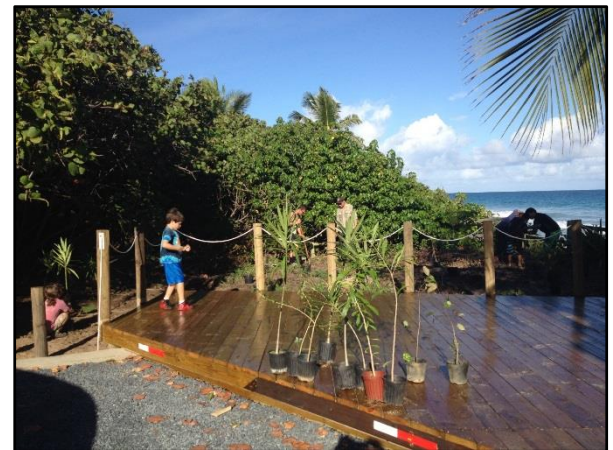
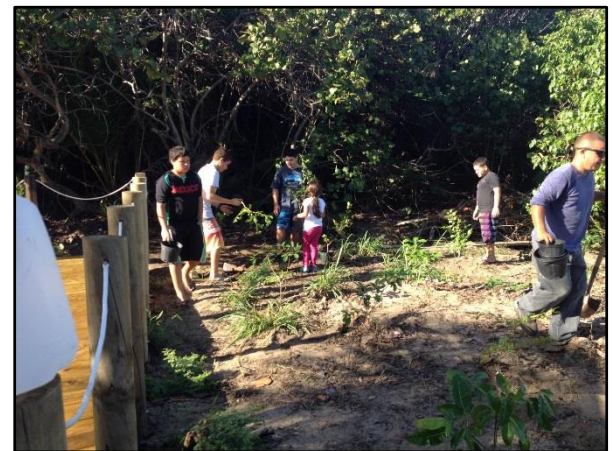
Figure 26. Process of reforestation of the vegetated zone of the beach with volunteers.

The coastal habitat at Zoní Beach has been seriously impacted by uncontrolled public access and erosion caused by concentrated flow. In order to restore the coastal vegetated berm and buffer, we re-planted the area with coastal native species. Plant material was provided by DNER and USFWS. A total of approximately 300 native trees were planted with active collaboration of local groups such as kids from Abbie's School and USFWS volunteers. Abbie's School was in charge of the watering and maintenance of the planted trees for 5 to 6 weeks. A cistern system was installed in the area and water was coordinated with the Municipality of Culebra (Figure 26).

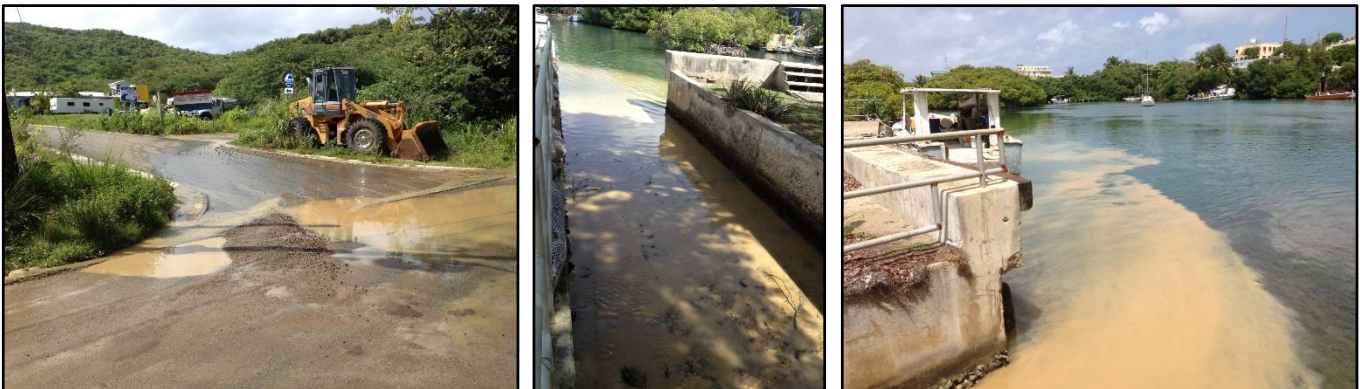
Figure 28. Water tank overflow prior to stabilization.

Another problem associated with this site is that when the water reservoir tank overflows it drains from top of the hill through a steep slope in a dirt channel it has created over time piping and erosion of fine sediments and carrying them to the near shore environment (Figure 28).

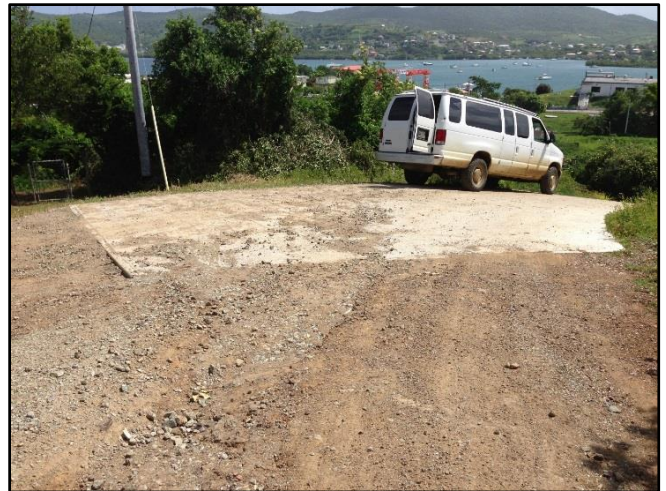
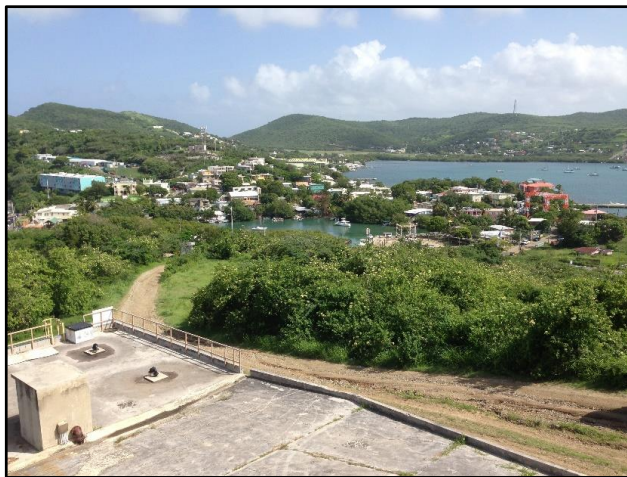
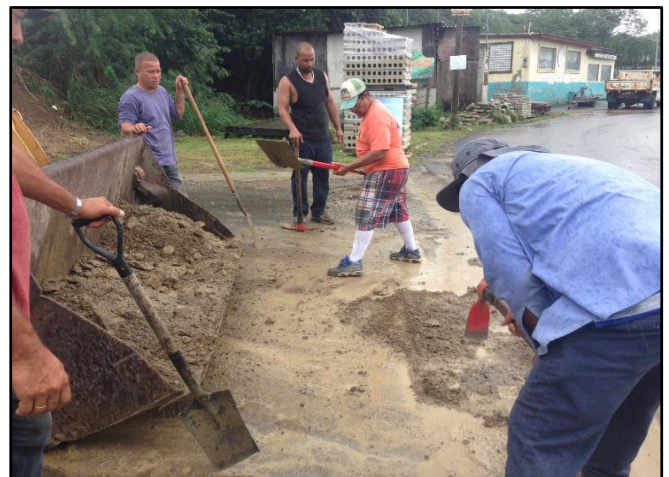
Figure 30. Town site prior to implementation.
